Variable Valves - Plus More

Last time (Fall 2010), we looked at two Nissan variable valve timing case studies, provided by John Thornton. There wasn't enough room in that issue for John's very informative third case study, so it's included here. After we've finished with the third case study, we'll move into an overview of the construction, operation and diagnosis of various crank sensor designs. Let's get started.

Our third case study involves a 2001 Nissan Sentra GXE, also with the 1.8L QG18DE engine found in the first two case studies. The vehicle failed an Illinois OBD II inspection for a P0335 crank sensor diagnostic trouble code (DTC). If the DTC is cleared, it resets very quickly and matures to a stored DTC. The code definition suggests that a DTC P0335 may be caused by a POS/PHASE sensor synch issue. The engine also surged at idle. Figure 1 on page 3 illustrates the idle surge in PARK and DRIVE.

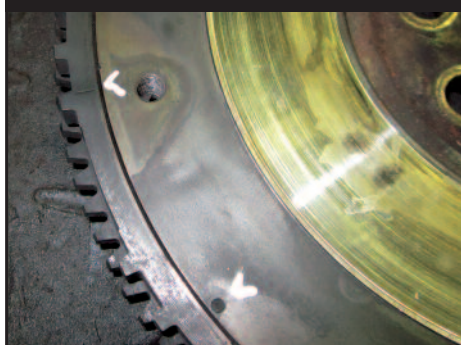
The painted arrows in this photo highlight assembly marks on the flywheel and exciter ring gear. These marks should be aligned.

As you can see clearly in the photo above, the exciter ring gear had moved. The ring gear is an interference shrink fit to the flywheel, with

what appear to be punch marks for insurance. There are no actual spot welds to hold it in place. After replacing the flywheel (the dealer had two in stock), the engine ran great again.

The question is what could have made the exciter ring slip? After looking a little closer, it appeared there was some heat discoloration where the clutch disc contacted the flywheel. I talked with Bob and he said the clutch had been replaced twice in this vehicle. Keep in mind that it has only 65,000 miles on it. Does this indicate a problem with the pressure plate, clutch disc or the driver's habit of riding the clutch? It is unknown at this time, but it does appear excessive heat had something to do with the exciter ring movement.

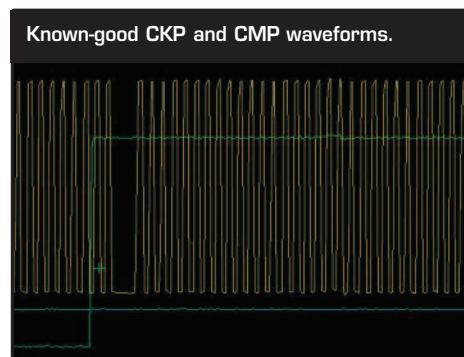
The screen capture above shows known-good crank and cam sensor patterns taken from a 2004 Kia Rio with a standard transmission. These patterns are also available on our website.

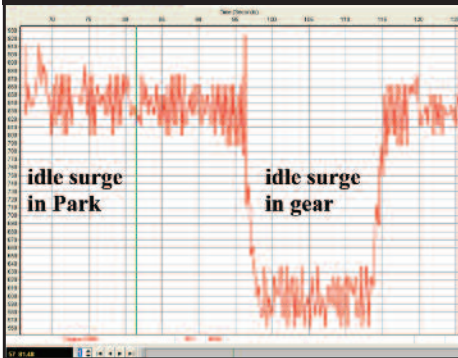
Figure 1: This screen capture illustrates the Nissan Sentra idle surge.

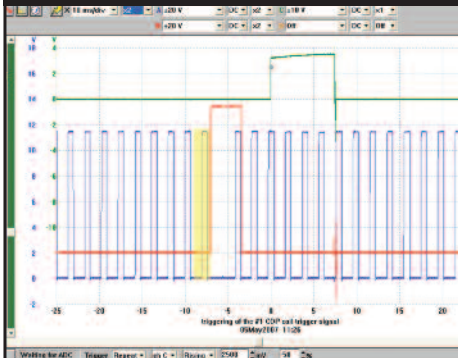
When energized, the variable valve timing system should advance the intake cam timing by 20 crankshaft degrees. However, the exhaust cam sensor waveform appears to be retarded by about 10 crank degrees. The timing chain is probably stretched, which also caused the P0355. Although the variable valve timing mechanism causes the intake camshaft to advance as it should, the intake camshaft timing also is about 20 crankshaft degrees retarded. This is probably responsible for the surge. The intake cam sprocket may have jumped a tooth, or there may be another mechanical explanation.

Figure 2: This is a known-bad pattern. The exhaust cam appears to be retarded about 10 crank degrees.

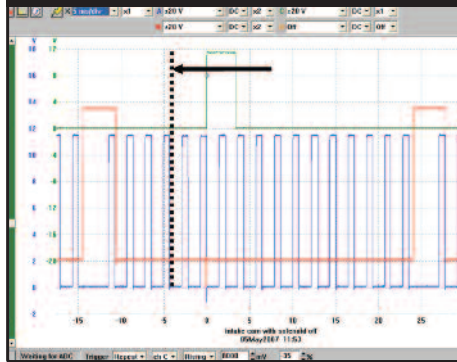
Refer to the waveforms in Figures 2 and 3 on page 3. The crank (POS) and exhaust cam (PHASE) sensor waveforms are in their usual locations, but we've added a third waveform at the top. This waveform was produced by the intake camshaft sensor.

Figure 3: The signal from the intake camshaft speed sensor should occur at the dotted line.

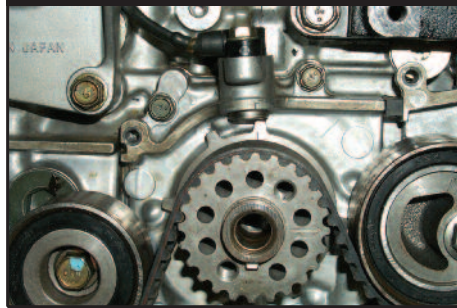
Figure 4: This crankshaft position sensor is located above a reluctor with a distinctive tooth sequence.
