Case Study: No Snap Decisions

This issue's case study was contributed by Dave Heinzen.

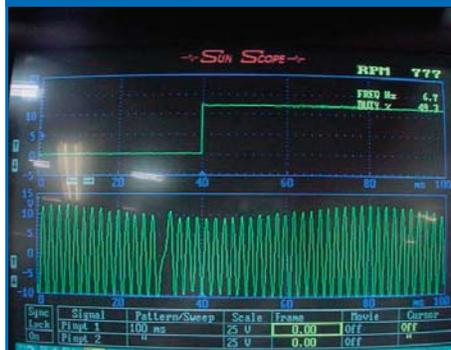
We pulled out a lab scope. A dual trace of the cam and crank sensors revealed the waveforms shown in Figure 1. You can see the sync pulse of the crank sensor and its relationship to the cam sensor, but this information means nothing if you don't know how it's supposed to look. So we hopped on the Internet, hoping that someone had saved a "known-good" cam/crank relationship waveform for one of these 3.8's. We got lucky and found a '95 Mustang 3.8 known-good.

Figure 1: Bad cam and crank sensor SYNC waveforms.

The cam sensor is a different design on the Mustang. But assuming nothing is different with the logic on these shaft sensors from one platform to another, it appeared we were off by 50 degrees. The crank sensor reluctor has a tooth every 10 degrees, with one missing for the sync — for a total of 35 teeth. It looked like it was time to pull the front cover.

What if we flashed a timing light on the TDC mark we made? It may not be very accurate, but if the timing were way off, it would support the direction we were heading. So we did, and the timing was about 50 degrees off.

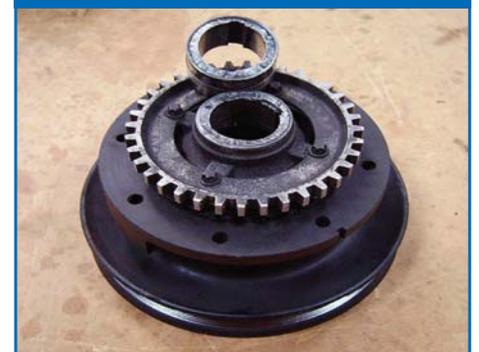
Figure 2 says it all. The hub of the balancer had broken off, allowing the balancer to spin in relation to the crank, then grab again. It probably stopped where it did because the engine could not develop enough torque to spin it any further. This is not a case of a balancer spinning on the rubber insulator. That would not have caused this problem since the reluctor is bolted to the center of the balancer.

Figure 2: Broken crank balancer and reluctor.

After a new balancer and an oil change, the Windstar ran great, rattling cat and all. But with the engine's normal torque restored, we could clearly hear a nasty rod knock. Good thing we didn't throw a bunch of parts at it.
