A Compelling Case Study

This issue's case study was contributed by Jim Gehl.

This case study concerns a 1997 Pontiac Gran Prix that has a 3.8L engine and about 100,000 miles on it. The problem with the vehicle is very intermittent. The engine may start and run fine all day. But at other times, the engine may not start on the first attempt of the day, or it may take several tries before it will start and run. The engine also may die while driving, but restart immediately. Or it may die while driving and not restart until allowed to cool down.

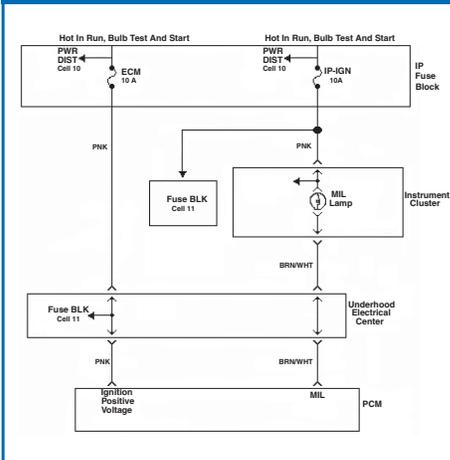
About the only thing we have to start with is a diagnostic trouble code (DTC) P0560 (System Voltage) stored in the PCM's memory. The DTC indicates that the PCM has lost voltage on one or both of its supply voltage circuits. But the engine is running fine right now. Figure 1 on page 3 is the schematic that is to be used with the diagnostic procedure for this DTC.

Figure 1: This wiring diagram illustrates the power supply from the fuse block to the PCM.

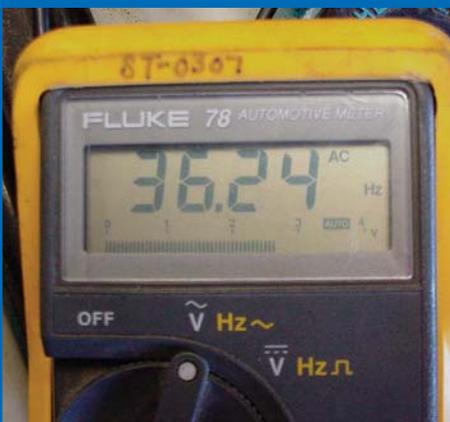
36.24 Hz was the DMM reading for the 3X sensor (Figure 2), so it checked out okay. Pins G and C at the ICM send and receive the ignition system's 18X signal. Pin G is the input from the CKP and pin C is the ICM output to the PCM. I found nothing abnormal with either the 3X or 18X inputs and outputs, but the vehicle suddenly decided it didn't want to start during the test. I quickly determined the ignition was still working, but there was no fuel pressure during the no-start. Now what?

Figure 2: The ignition system's 3X signal was verified by attaching a DMM, set to measure frequency (Hz).

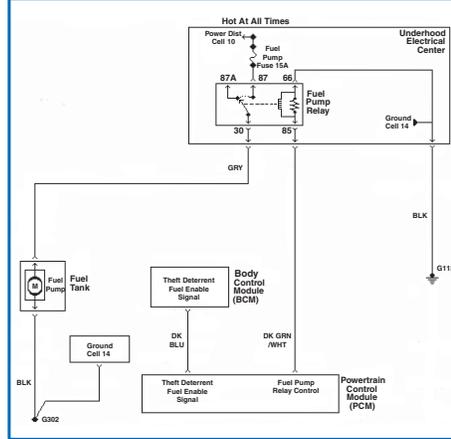
Let's check the fuel pump and its circuit next to see if the fuel pump can function. I need to prove the fuel pump is not responsible for the no-start condition. What circuit controls the fuel pump relay? What circuit supplies the power for the fuel pump? Looks like it's time to get out the wiring diagram and component locator (Figure 3).

Figure 3: Fuel pump wiring diagram.

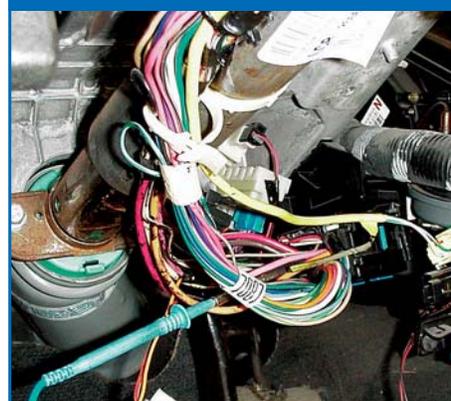
The wiring diagram in Figure 1 indicates the circuit goes inside the vehicle to the instrument panel (IP) fuse block. My DMM showed the same voltage inside as outside the fuse block. Imagine that. The wiring diagram also indicates that the PCM supply voltage originates at the ignition switch, so I checked there next (Figure 4). The voltage at the ignition switch feed to the fuse was only 3.91 volts (Figure 5). The rest of the circuits from the ignition switch were working properly, so right then I knew I had found the cause of the intermittent stalling and no-starts.

Figure 4: Voltage feed to the fuel pump relay, measured at the ignition switch.

After replacing the ignition switch, the PCM fuel pump relay control voltage was 10.6 volts. Now, that's more like it!

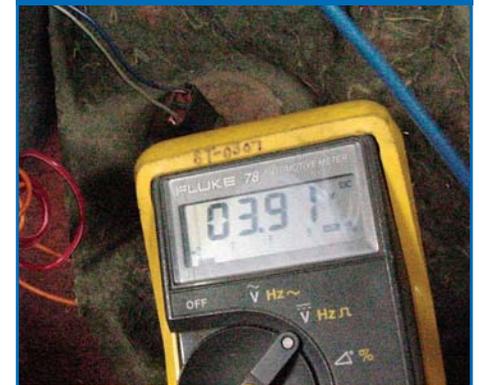
The PCM also must supply adequate voltage to energize the fuel pump relay windings. When I checked the voltage at fuel pump relay terminal 85, my DMM only indicated 3.67 volts. Something doesn't seem right here. The PCM has to supply more than 3.67 volts to the fuel pump relay coil windings. There must be a very large voltage drop before this part of the circuit.

Figure 5: 3.91 V won't energize the fuel pump relay. Time to identify the source of the voltage drop.

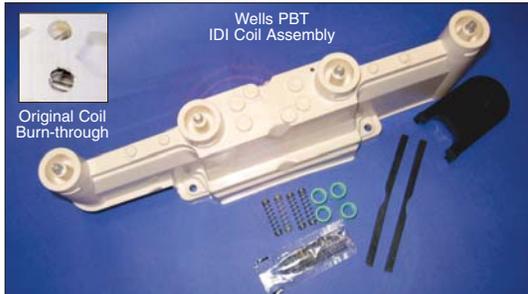
during the injection molding process. These air pockets weaken the unit’s dielectric strength, and eventually cause the coil towers to burn through and short to each other. An

example of this type of damage can be seen in the inset photo.

Pockets of air or bubbles can be trapped in the plastic between the DIS coil towers

Wells has developed a precise two-step injection molding process to prevent air from being trapped in the Polybutadiene-Terephthalate (PBT)

plastic (main photo). This unique process eliminates these failures.
