A Compelling Case Study

This issue's case study was contributed by Jim Gehl.

This case study concerns a 1997 Pontiac Gran Prix that has a 3.8L engine and about 100,000 miles on it. The problem with the vehicle is very intermittent. The engine may start and run fine all day. But at other times, the engine may not start on the first attempt of the day, or it may take several tries before it will start and run. The engine also may die while driving, but restart immediately. Or it may die while driving and not restart until allowed to cool down.

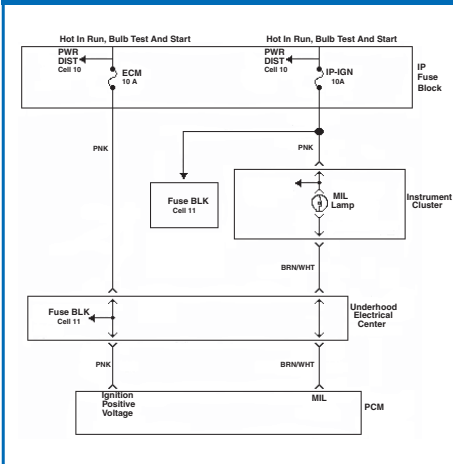
About the only thing we have to start with is a diagnostic trouble code (DTC) P0560 (System Voltage) stored in the PCM's memory. The DTC indicates that the PCM has lost voltage on one or both of its supply voltage circuits. But the engine is running fine right now. Figure 1 on page 3 is the schematic that is to be used with the diagnostic procedure for this DTC.

Figure 1: This wiring diagram illustrates the power supply from the fuse block to the PCM.

The wiring diagram in Figure 1 indicates the circuit goes inside the vehicle to the instrument panel (IP) fuse block. My DMM showed the same voltage inside as outside the fuse block. Imagine that. The wiring diagram also indicates that the PCM supply voltage originates at the ignition switch, so I checked there next (Figure 4). The voltage at the ignition switch feed to the fuse was only 3.91 volts (Figure 5). The rest of the circuits from the ignition switch were working properly, so right then I knew I had found the cause of the intermittent stalling and no-starts.

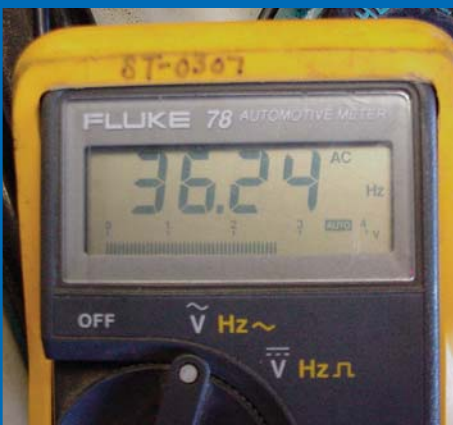
36.24 Hz was the DMM reading for the 3X sensor (Figure 2), so it checked out okay. Pins G and C at the ICM send and receive the ignition system's 18X signal. Pin G is the input from the CKP and pin C is the ICM output to the PCM. I found nothing abnormal with either the 3X or 18X inputs and outputs, but the vehicle suddenly decided it didn't want to start during the test. I quickly determined the ignition was still working, but there was no fuel pressure during the no-start. Now what?

Figure 2: The ignition system's 3X signal was verified by attaching a DMM, set to measure frequency (Hz).

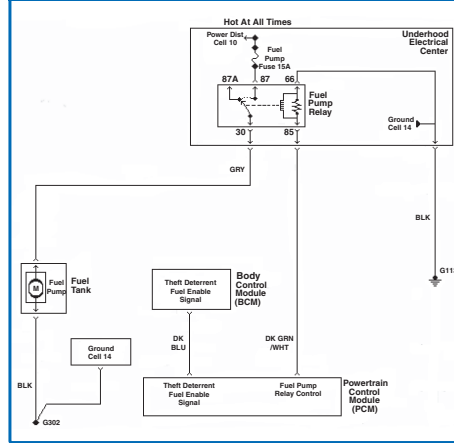
Let's check the fuel pump and its circuit next to see if the fuel pump can function. I need to prove the fuel pump is not responsible for the no-start condition. What circuit controls the fuel pump relay? What circuit supplies the power for the fuel pump? Looks like it's time to get out the wiring diagram and component locator (Figure 3).

Figure 3: Fuel pump wiring diagram.

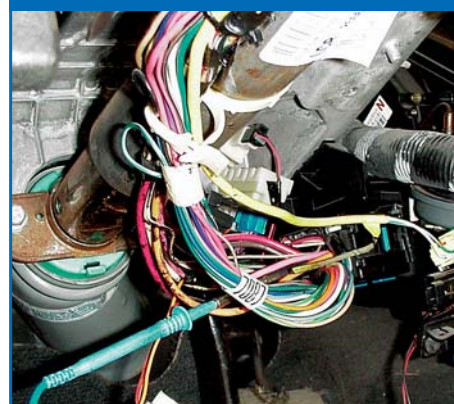
Figure 4: Voltage feed to the fuel pump relay, measured at the ignition switch.

The search led us to the ignition switch. The ignition switch had not failed completely, but was failing intermittently. The failure also seemed to have a temperature component, because the vehicle would always restart when allowed to cool down. Although this failure caused a loss of fuel pressure, the fuel pump was not to blame. **WELLS**

After replacing the ignition switch, the PCM fuel pump relay control voltage was 10.6 volts. Now, that's more like it!

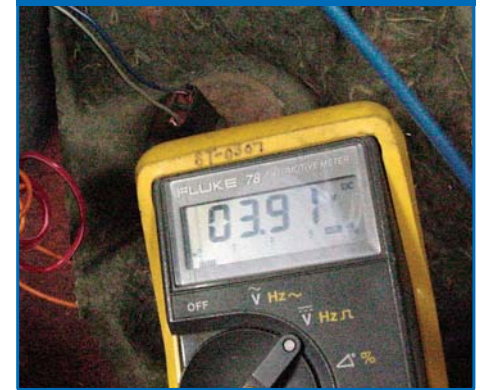
The PCM also must supply adequate voltage to energize the fuel pump relay windings. When I checked the voltage at fuel pump relay terminal 85, my DMM only indicated 3.67 volts. Something doesn't seem right here. The PCM has to supply more than 3.67 volts to the fuel pump relay coil windings. There must be a very large voltage drop before this part of the circuit.

Figure 5: 3.91 V won't energize the fuel pump relay. Time to identify the source of the voltage drop.

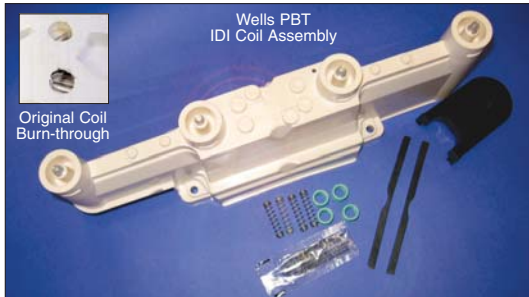
In 1987, GM introduced the DIS system called the Integrated Direct Ignition (IDI) system and incorporated it into the popular Quad IV engine. Some techs named it a “cassette ignition system” because of the appearance of the module under the cover. A common problem with this system was the occurrence of a two-cylinder misfire that was often accompanied by a no-start condition, especially in cold climate areas.

during the injection molding process. These air pockets weaken the unit’s dielectric strength, and eventually cause the coil towers to burn through and short to each other. An

example of this type of damage can be seen in the inset photo.

Pockets of air or bubbles can be trapped in the plastic between the DIS coil towers

Wells has developed a precise two-step injection molding process to prevent air from being trapped in the Polybutadiene-Terephthalate (PBT)

plastic (main photo). This unique process eliminates these failures.
