The Triangle Of Doom

Hybrid repairs may be coming your way. Is your shop ready for this rapidly emerging technology?

The following challenge involves a 2001 Toyota Prius hybrid with 98K on the odometer. While driving, the owner noticed a warning light on the dash. The warning light was shaped like an exclamation point inside a red triangle. It looked serious, so the owner decided to take the vehicle to the Toyota dealer. The service adviser listened to the owner's complaints and checked the vehicle dash for the illuminated triangle. His next step was to write up the repair order (RO) and assign the shop's certified hybrid technician.

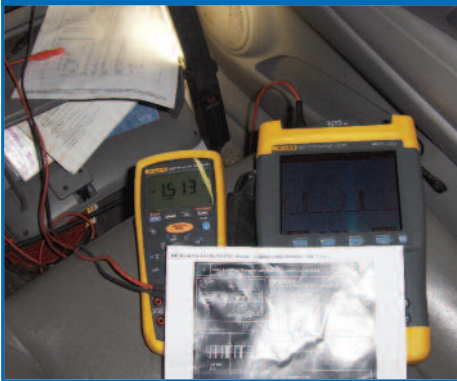
Figure 1: Checking voltage between HTE+ and HTE-

Following the Toyota flowchart and checking voltage between HTE + and HTE - of the ECM, I came up with a reading of 1.49 volts and a waveform that matched Toyota's example (Figure 1). The Toyota flowchart then states that the ECM should be replaced. I've been around awhile, and it's hard for me to swallow replacing an ECM without first checking every sensor and component that is associated with it. I think that flowcharts should be renamed "trouble charts" because in many cases that's what you will find yourself in.

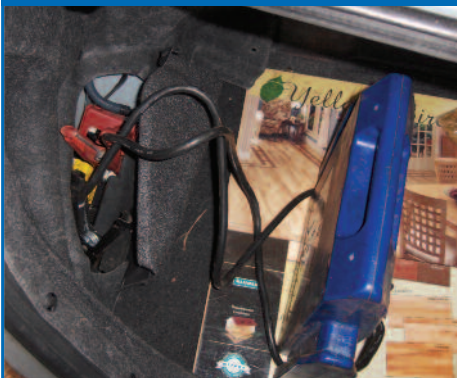
Figure 2: Installing battery pack on AGM battery

Since the flowchart did not make sense to me, I decided to get back to the basics and test the 12-volt battery. I found that the vehicle's absorbed glass mat (AGM) 12-volt battery was below specification. A word of caution is in order concerning this battery. Be careful when charging the AGM 12-volt battery because it can and will be damaged if the charging current surpasses 3.5 amps.

As you can see in Figure 2, I installed a battery pack and retested the ECM just to

verify I was testing with the correct voltage. While retesting, I captured the identical meter and scope readings, with one difference: the DTC P1636 was gone.

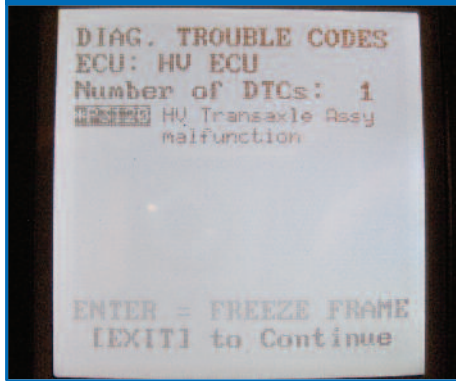
Figure 3: DTC P3120 HV Transaxle Assy Malfunction

DTC P3002 (HV Serial Communication Abnormality) deals with a communication problem to the HV ECU. This DTC was coming back even with the 12-volt AGM battery fully charged. I knew this vehicle now had a hard problem in the HV system but I proceeded to check the other DTCs. P3120 (HV Transaxle Assembly Malfunction) (Figure 3) confirmed the DTC HV P3002, but I had to look into the sub system DTC 253 Generator Resolver Inter-Phase Short. The sub system DTC lead me to the cause of my HV problem. The MG had a shorted winding that I confirmed with my megohm meter (Figure 4 - Bad & Figure 5 - Good.)

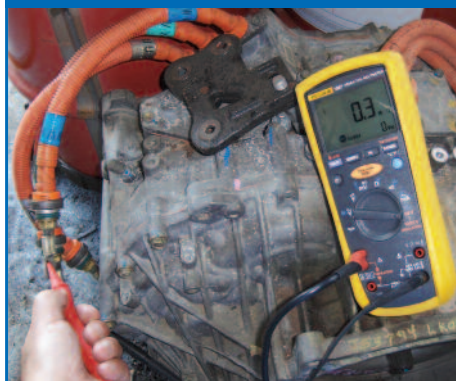
Figure 4: Hybrid transaxle with shorted MG windings

I was confident with my diagnosis and recommended replacing the salvage yard transaxle. We waited three weeks for the salvage yard to locate a replacement. When it arrived, we made sure to check the unit for visible damage and/or shorted windings. The transaxle was replaced for the second time, test driven and checked for DTCs, all without any problems. The Prius was ready to be returned to the customer, minus the Triangle of Doom. **WELLS**

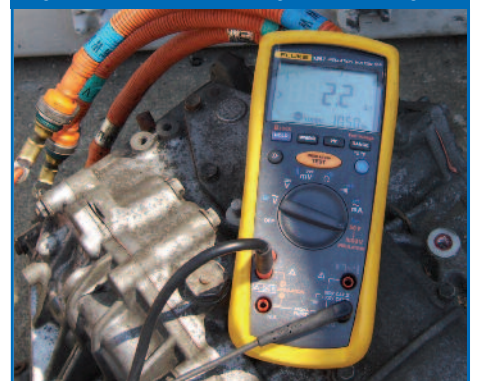
Figure 5: Second transaxle with good MG windings
