Nissan Variable Valve Timing

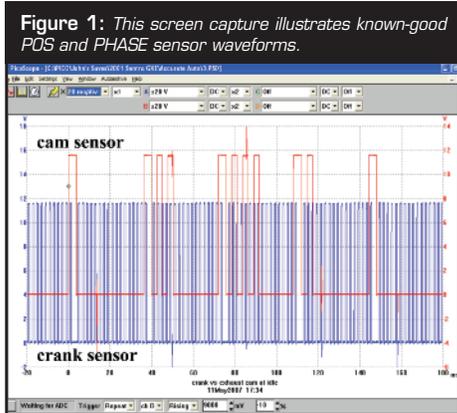
required to produce four groups of pulses in the firing order sequence. On the scope, look for a single pulse, followed by three pulses, followed by four pulses, then two pulses before the sequence repeats. The numbering and sequencing of the pulses in this series is the same as the engine's firing order (1, 3, 4, 2). Refer to Figure 1 for an example of known-good POS and PHASE sensor waveforms.

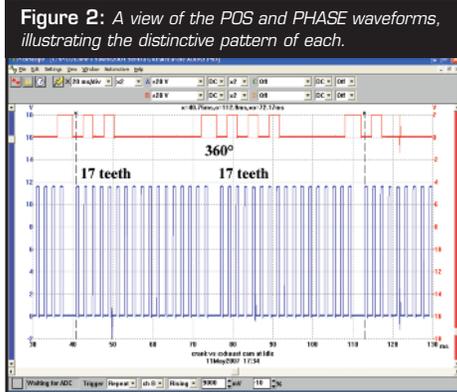
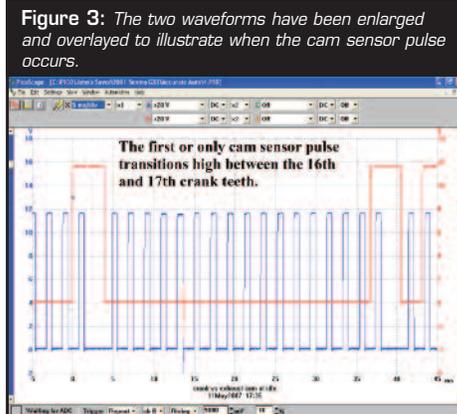
The POS and PHASE sensor waveforms have been enlarged in Figure 2. We've overlaid the waveforms and further enlarged them for a better illustration of the relationship between the two in Figure 3.

What did we learn? Each series of pulses in the PHASE sensor waveform begins between the 16th and 17th crank teeth pulses in the POS waveform. The first or only PHASE sensor pulse transitions low five crank degrees before the first POS sensor signal pulse. This is a normal relationship between the two sensor signals, and will be an important piece of information in our upcoming diagnosis. These waveforms were collected on a 2001 Nissan Sentra GXE 1.8L with 35,000 miles.

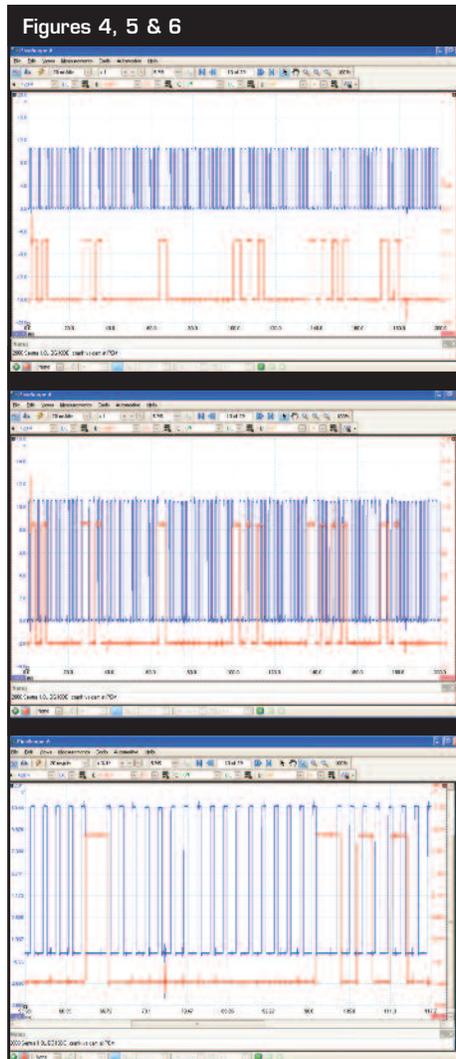
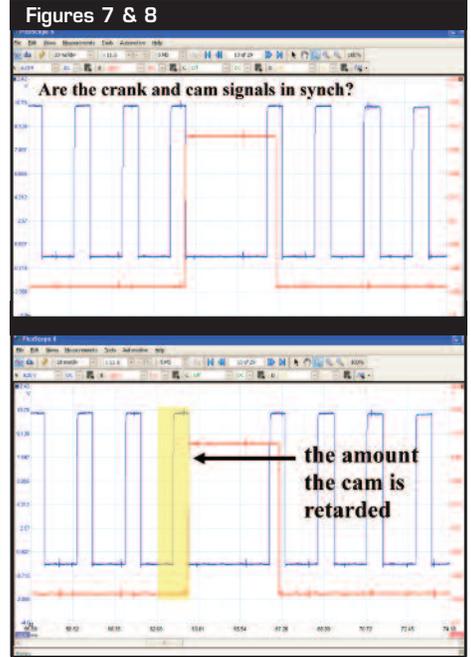
Refer to the series of waveforms in Figure 4 through 8. Are the crank and cam signals in sync? It looks like the cam timing is off. The crank-to-cam relationship is incorrect.

We've gradually zoomed in on the sensor waveforms in this series of screen captures, to illustrate the relationship between the two. In the last two screen captures, it's very apparent that the cam sensor's waveform is retarded.

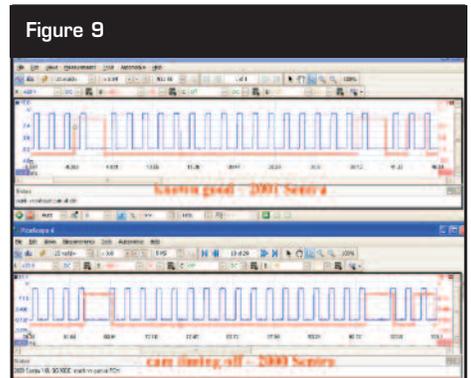
Figure 9 shows the retarded cam timing when compared to a known-good vehicle. Further diagnosis will be required to determine the cause of the problem. Is the timing chain stretched? Has the chain jumped a tooth? At 98,000 miles, either of these defects is a distinct possibility.
