WELLS Counter Point

Volume 8 Issue 2, Spring 2004

Ford Distributor Ignition Diagnosis

Even a carefully considered diagnosis can go astray. Our recent experience proves the point.

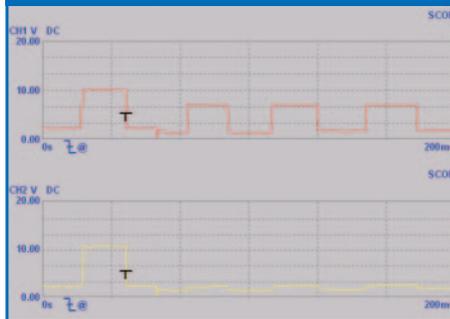
After consulting a wiring diagram, we learned a couple of things. First, we learned this was not a PS system, because it had a black module. We also determined that the ICM *does* need to look at the SPOUT signal during cranking to decide when to fire the coil. Our earlier assumption that only PIP was needed to start the engine was incorrect. We attached the GMM to the SPOUT terminal, then attempted to start the engine. When the engine would start, the SPOUT signal looked normal. When it wouldn't start, SPOUT was very weak with just a slight ripple above ground visible in the GMM trace.

Figure 1: This screen capture shows PIP (top) and SPOUT (bottom) while cranking during the no-start. Notice SPOUT is dropping out. This is why we decided to replace the ICM.

The intermittent weakness of the SPOUT

signal seemed to point to the PCM, so we ordered up a replacement. Our jubilation was short-lived, however. After the replacement of two non-returnable electronic components, the hot soak no-start symptoms returned all too soon.

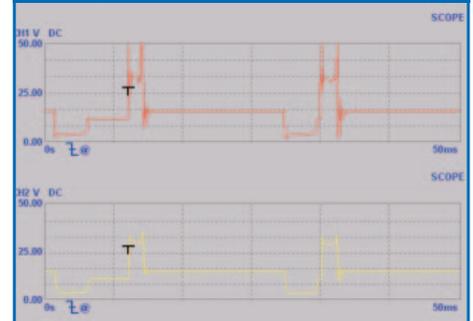
We also monitored the ignition diagnostic monitor (IDM) signal during this test. The IDM is a signal from the ICM to the PCM that verifies spark function. IDM is based on the flyback voltage (up to 400 volts) created by the ignition coil primary discharge. The IDM signal consists of a single pulse for each successful ignition event. If the IDM signal is missing, it's an indication of intermittent or missing spark events. When we had no spark indicated by the timing light, the IDM signal was also missing. The PIP sensor signal continued to look normal.

Figure 2: The coil primary pattern is at the top of this GMM screen capture. The IDM pattern, which mirrors the primary and confirms each ignition event to the PCM, is at the bottom. The engine was running at this time.
