Beyond the Diagnostic Trouble Tree

Ford Distributor Ignition Diagnosis - Part Two

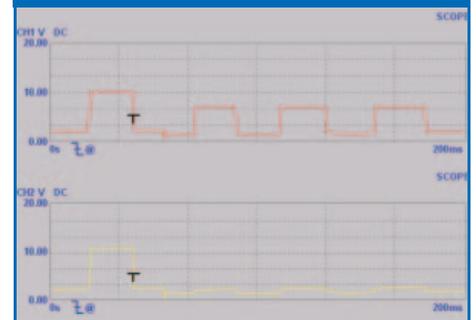
This is where the clue from Part One comes in. Refer to the scope patterns shown in Figure 1 on this page. This is the same illustration we showed you the first time around, also identified as Figure 1. Notice that the SPOUT signal (bottom pattern) starts out okay, but then begins to drop out. Now take a look at

when the dropout starts. The dropout occurs immediately after the PIP signal (upper pattern) drops below the required threshold voltage.

The intermittent no-start was caused by a failing PIP sensor that was only able to manage a peak amplitude of about 6.0 volts after a hot soak. This was still enough to satisfy the ICM, but not the PCM. When the PIP sensor's peak signal voltage dropped below the 6.5 volt threshold, the PCM couldn't recognize it. The best the PCM could do was to produce the weak SPOUT signal we had observed during the Mustang's no-start episodes.

Figure 1: This screen capture shows PIP (top) and SPOUT (bottom) during no-start cranking. SPOUT began dropping out as soon as PIP dropped below the threshold voltage.

Things were back to normal after a new PIP sensor was installed. The new sensor produced a healthy square wave with a peak amplitude of over 9.0 volts — more than enough to satisfy the minimum threshold requirement of both the ICM and the PCM. And the sensor was completely unaffected by changes in temperature and hot soaks.
