Jeep Ignition Sync Problems

Our problem vehicle is a 2000 Jeep Cherokee with an automatic transmission and 4.0L engine. The engine is hard to start and occasionally will not start at all. The basics, including battery, vacuum, spark and timing, have already been checked by another shop. A number of "known good" parts from an identical vehicle have also been substituted, with no improvement.

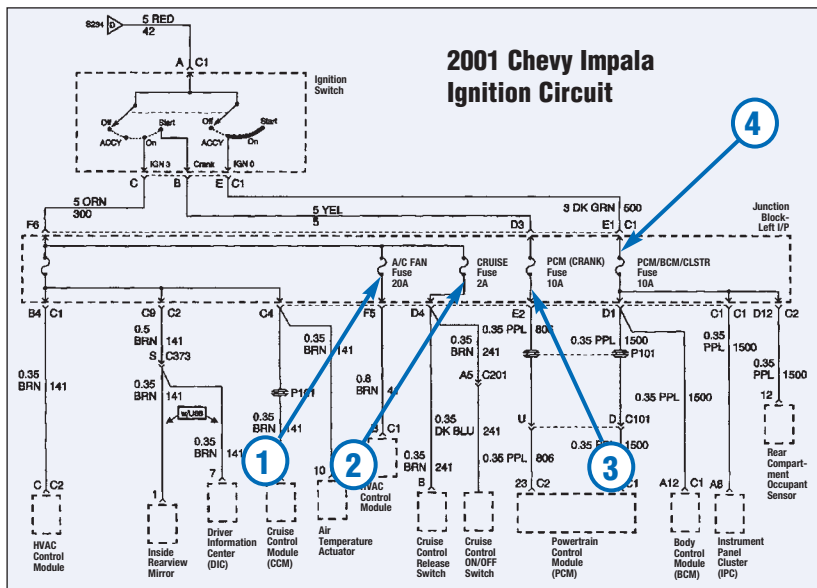
Refer to the wiring schematic at the bottom of this page. We can perform a voltage drop test across this circuit by connecting our meter to connections 1 or 2 and 4 in the fuse panel. The meter read 10.16 volts when the problem occurred, indicating a huge voltage drop across this circuit and proving the ignition switch was

defective. A fifth page with pictures of this test has been added to the PDF version of the Summer *Counter Point*. It's available for download at our website (www.wellsmfgcorp.com).

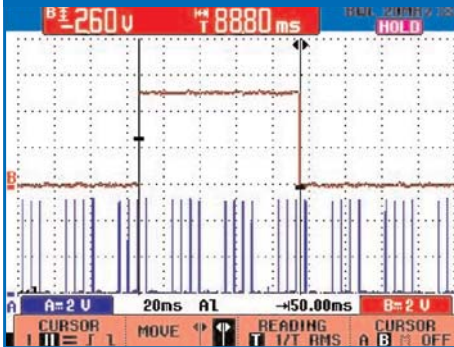
Figure 2: Bad cam and crank sensor SYNC waveforms.

Look carefully at the Jeep's crank and cam sensor waveforms in Figure 2's bad screen capture. Channel A in blue is the crank signal and Channel B in red is the cam sensor. Notice the vertical cursor lines, which make it easier to check for sync. This Jeep was way out of sync, as you can see by comparing the bad screen capture to the good screen capture in Figure 3. It's easy to know what's bad if you know what's good, which is why it's important to build a library of known-good waveforms and keep them handy for later reference. I call this comparison method *color form technology*. The explanation of what's wrong with Figure 2 follows.

When it is properly in sync, the cam sensor signal must begin and end in the gap between the three groups of four crank sensor pulses. You will notice in the bad screen capture that the cam sensor signal does not bracket the group of crank sensor signals as it should. Instead, it begins and ends during the crank

sensor signal groups. Look at the difference in the crank signal's three groups of four pulses in relationship to the cam signal in the good screen capture. It's noticeable that the group of crank sensor signals fits right into the cam sensor signal's rise and fall. However you chose to view it, the difference is clear. Remember, the scan tool PID reported that the system was in sync at the same time that I collected the bad screen capture.

This out of sync condition occurs when the oil pump drive shaft binds inside the oil pump drive housing, causing the entire housing to rotate slightly. The cam position sensor is located at the top of the oil pump drive housing, where the old distributor, cap and rotor used to be located. In extreme cases, the oil pump drive shaft or its camshaft mating gears may break, causing a no-start condition. More commonly, the housing rotates slightly, causing the out of sync condition seen here. If the housing does not appear to be parallel with the block or shows other signs of movement, the fix is to install a new housing that's been properly prelubed.

Refer to a computer-based repair information system or a printed repair manual for the proper cam sensor setup and installation procedure. Use a drill bit to line up and set the cam sensor. The hole in the shaft needs to be aligned with the hole in the cam vane blade. After installing the new parts, check the sync with your scope to verify the repair. The older engines used a similar setup. However, this newer style ignition system uses a Hall effect crank sensor—not an AC-generating crank sensor.

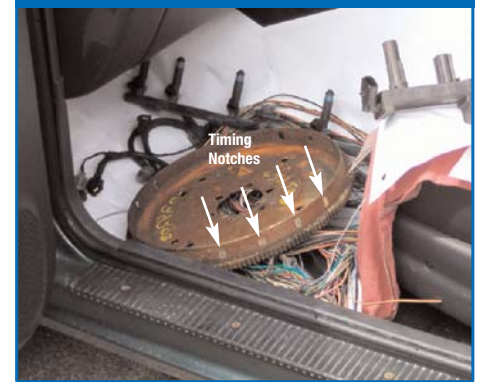
Figure 4: Flywheel/flexplate showing timing notches.

This engine uses a flex plate/flywheel that has three groups of four notches arranged around its outer circumference to determine piston position (refer to the arrows in the flex plate/flywheel photo in Figure 4). These notches are read by the crank sensor as they pass beneath it. The trailing edge of the fourth notch in each group occurs four degrees before top dead center (TDC) of the corresponding piston.
