Jeep Ignition Sync Problems

This issue's case study was contributed by Jerry Truglia.

Our problem vehicle is a 2000 Jeep Cherokee with an automatic transmission and 4.0L engine. The engine is hard to start and occasionally will not start at all. The basics, including battery, vacuum, spark and timing, have already been checked by another shop. A number of "known good" parts from an identical vehicle have also been substituted, with no improvement.

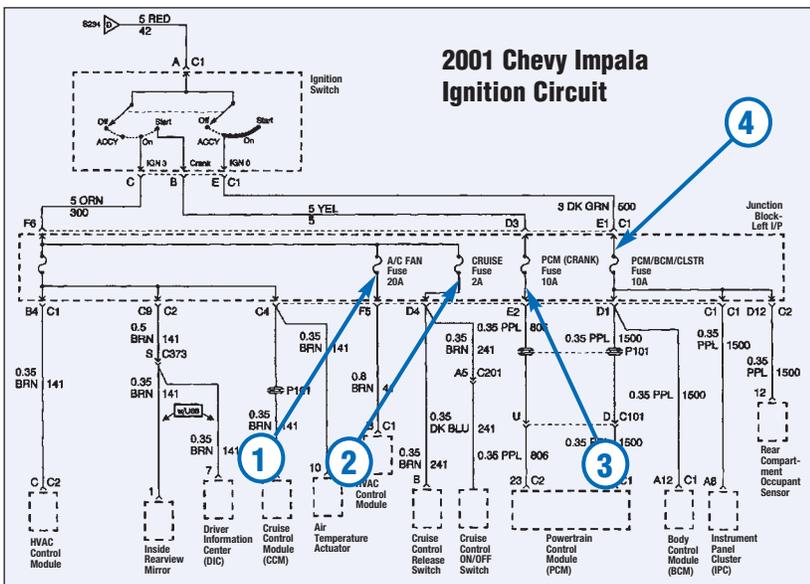
Refer to the wiring schematic at the bottom of this page. We can perform a voltage drop test across this circuit by connecting our meter to connections 1 or 2 and 4 in the fuse panel. The meter read 10.16 volts when the problem occurred, indicating a huge voltage drop across this circuit and proving the ignition switch was

defective. A fifth page with pictures of this test has been added to the PDF version of the Summer *Counter Point*. It's available for download at our website (www.wellsmfgcorp.com).

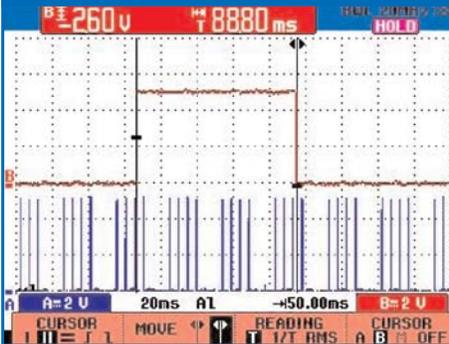
Figure 2: Bad cam and crank sensor SYNC waveforms.

Look carefully at the Jeep's crank and cam sensor waveforms in Figure 2's bad screen capture. Channel A in blue is the crank signal and Channel B in red is the cam sensor. Notice the vertical cursor lines, which make it easier to check for sync. This Jeep was way out of sync, as you can see by comparing the bad screen capture to the good screen capture in Figure 3. It's easy to know what's bad if you know what's good, which is why it's important to build a library of known-good waveforms and keep them handy for later reference. I call this comparison method *color form technology*. The explanation of what's wrong with Figure 2 follows.

When it is properly in sync, the cam sensor signal must begin and end in the gap between the three groups of four crank sensor pulses. You will notice in the bad screen capture that the cam sensor signal does not bracket the group of crank sensor signals as it should. Instead, it begins and ends during the crank

sensor signal groups. Look at the difference in the crank signal's three groups of four pulses in relationship to the cam signal in the good screen capture. It's noticeable that the group of crank sensor signals fits right into the cam sensor signal's rise and fall. However you chose to view it, the difference is clear. Remember, the scan tool PID reported that the system was in sync at the same time that I collected the bad screen capture.

This out of sync condition occurs when the oil pump drive shaft binds inside the oil pump drive housing, causing the entire housing to rotate slightly. The cam position sensor is located at the top of the oil pump drive housing, where the old distributor, cap and rotor used to be located. In extreme cases, the oil pump drive shaft or its camshaft mating gears may break, causing a no-start condition. More commonly, the housing rotates slightly, causing the out of sync condition seen here. If the housing does not appear to be parallel with the block or shows other signs of movement, the fix is to install a new housing that's been properly prelubed.

Refer to a computer-based repair information system or a printed repair manual for the proper cam sensor setup and installation procedure. Use a drill bit to line up and set the cam sensor. The hole in the shaft needs to be aligned with the hole in the cam vane blade. After installing the new parts, check the sync with your scope to verify the repair. The older engines used a similar setup. However, this newer style ignition system uses a Hall effect crank sensor—not an AC-generating crank sensor.

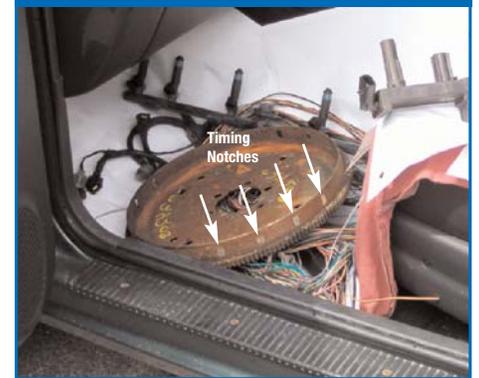
Figure 4: Flywheel/flexplate showing timing notches.

This engine uses a flex plate/flywheel that has three groups of four notches arranged around its outer circumference to determine piston position (refer to the arrows in the flex plate/flywheel photo in Figure 4). These notches are read by the crank sensor as they pass beneath it. The trailing edge of the fourth notch in each group occurs four degrees before top dead center (TDC) of the corresponding piston.
