# WELLS Counter

Volume 11 Issue 4, Fall/Winter 2007

THE ELECTRONIC, DIAGNOSTIC AND DRIVEABILITY RESOURCE.

## ABS Speed Sensors

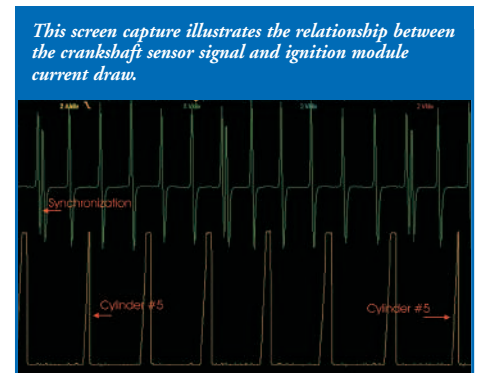
This is a problem on a 1995 Pontiac with a 3.1L engine that we diagnosed in our shop. The owner complained of a lack of power and engine shake. Our first step was to verify the complaint. It was obvious that the engine had a misfire, and our scan tool indicated the culprit was cylinder number 5.

Next, we backprobed the feed wire from the crankshaft position sensor to the control module and amp clamped the battery feed wire to the ignition control module. The labscope waveforms shown in the illustration below are the results of the test. The crank sensor produced the green waveform at the top of the screen capture, and the yellow waveform at the bottom represents the amperage draw to the control module.

**Question:** What could cause this type of amperage draw pattern on cylinder number 5?

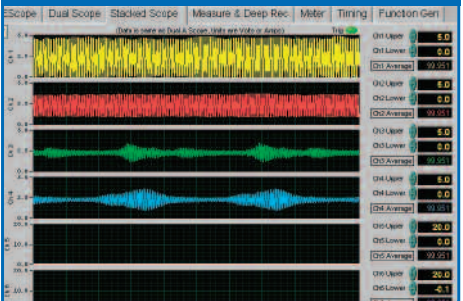
*Both rear axles had been replaced on this 1998 Lincoln Town Car. The trigger wheels were approximately .060-in. smaller in diameter than OE. This can be seen on channel 3 (green) and channel 4 (blue). There were no DTCs set, however this caused a false ABS activation to occur at low speeds.*

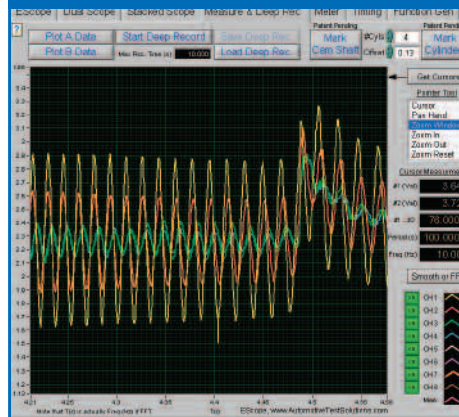
*This screen capture illustrates the speed signals on the same Lincoln during a false ABS activation.*

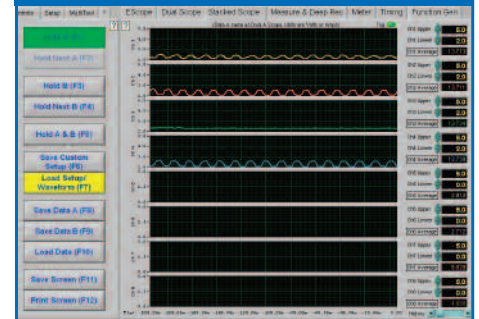
*During a routine brake job, one of the wheel speed sensors on this 1999 Subaru was hit and moved away from the tone wheel. This reduced the signal amplitude and caused false ABS activation. The fix was to readjust the sensor air gap at the right rear wheel.*
