# WELLS Counter Point

Volume 7 Issue 3, July 2003

## Forming a Diagnostic Strategy

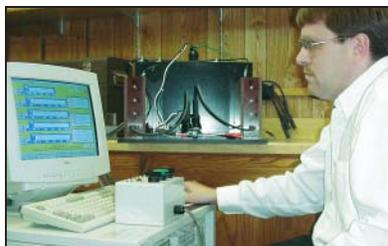
Using the Wells coil testing system, Engineer Tom Schaefer simulates actual operating conditions.

During the new testing procedures, each coil type is mounted in a specifically designed cradle. It is then run through a battery of tests that simulate the operating conditions the coil would experience if it were running in your customer's vehicle.

The coil tester supplies the primary windings with a current pulse, while simultaneously monitoring the primary/secondary voltages and current flow. Over two million voltage measurements are recorded for each of the nine test parameters. The computer uses

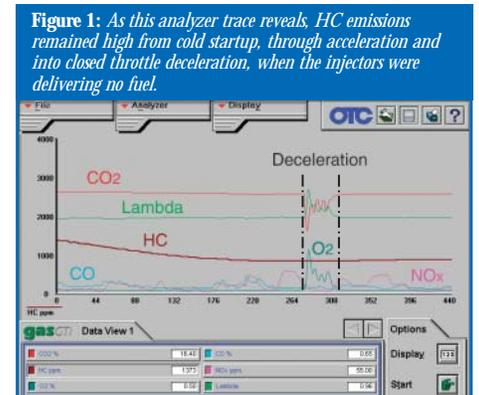
**Figure 1:** As this analyzer trace reveals, HC emissions remained high from cold startup, through acceleration and into closed throttle deceleration, when the injectors were delivering no fuel.

Other than the Check Engine light and the stored DTCs, the vehicle owner had reported no noticeable driveability problems. Where is the extra, unwanted fuel coming from? To find out more, we measured the post-catalyts exhaust emissions with a five gas exhaust analyzer, immediately after starting the engine cold. The results are shown in graph form in Figure 1.

HC starts out higher than normal and gradually declines. There was an abrupt deceleration between frames 264 and 308. Why is the engine running rich, especially if the PCM is trying to make it run lean? When this occurred, NO<sub>x</sub> went down, O<sub>2</sub> went up, Lambda went up (more about Lambda next),

CO<sub>2</sub> dipped and HC stayed about the same (still too high). All of these readings, except the high HC reading, are consistent with a lean mixture. We would expect to see a lean mixture at this time, because the injectors should be closed and all fuel should be cut during closed throttle deceleration. But the high HC reading indicates the presence of unburned fuel. This would seem to indicate that the engine was running rich and lean at the same time, which certainly seems impossible. In the next *Counter Point*, we'll explain how we finished our diagnosis and identified the fault.
