WELLS Counter Point

Volume 9 Issue 1, Winter 2005

Evaporative Emissions Systems Part Two

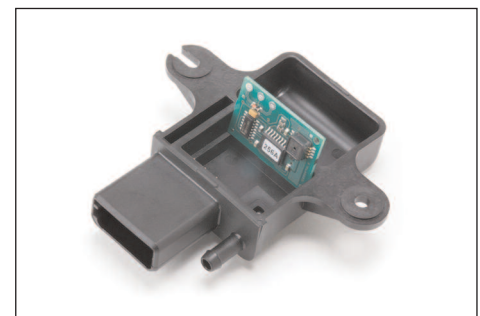
Figure 2 A non-potted, partially assembled Wells MAP sensor, with board tilted up to reveal ICs.

To overcome the shortcomings of the original design, Wells updated the circuitry to incorporate faster, more intelligent chips. The pressure sensor inside our MAP sensor is also adhered to the vacuum connection, eliminating the trend failure of the original design. A Wells MAP sensor is shown in *Figure 2*.

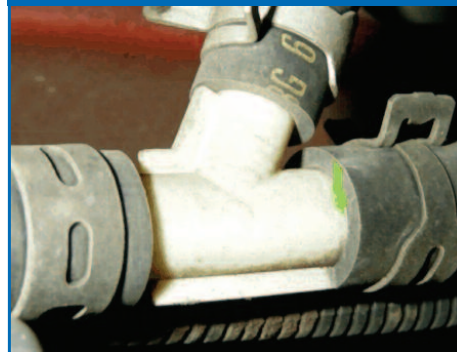
The smoke produced by EVAP-approved smoke machines includes a UV dye that leaves a fluorescent deposit at the leak. (photos courtesy Vacutec)
